**ASBESTOS SURVEY  
& LEAD PAINT SAMPLING  
FOR DEMOLITION OF THE BUILDING  
LOCATED AT 40600 HWY 299  
WILLOW CREEK, CA**

May 3, 2024

Project # 2403401

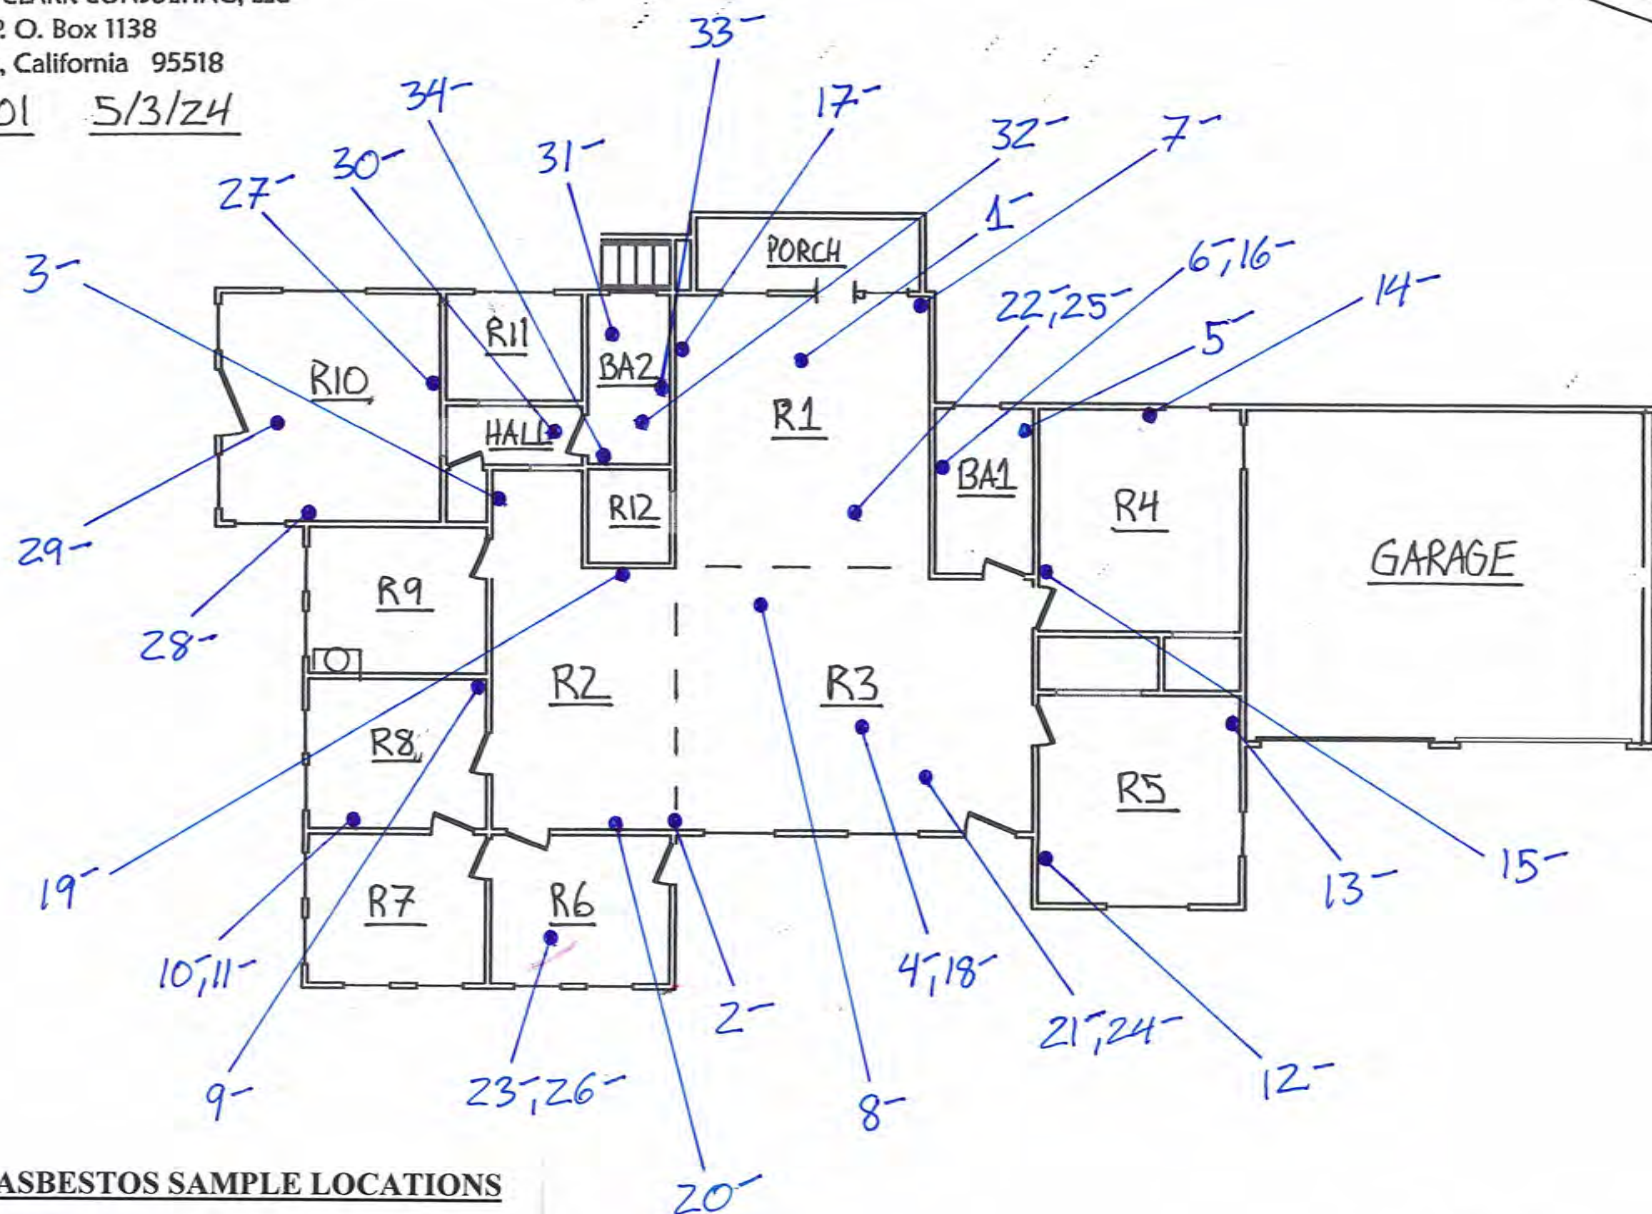
FIG. 1

# ASBESTOS SAMPLE LOCATIONS

(Asbestos Samples: 1-34)

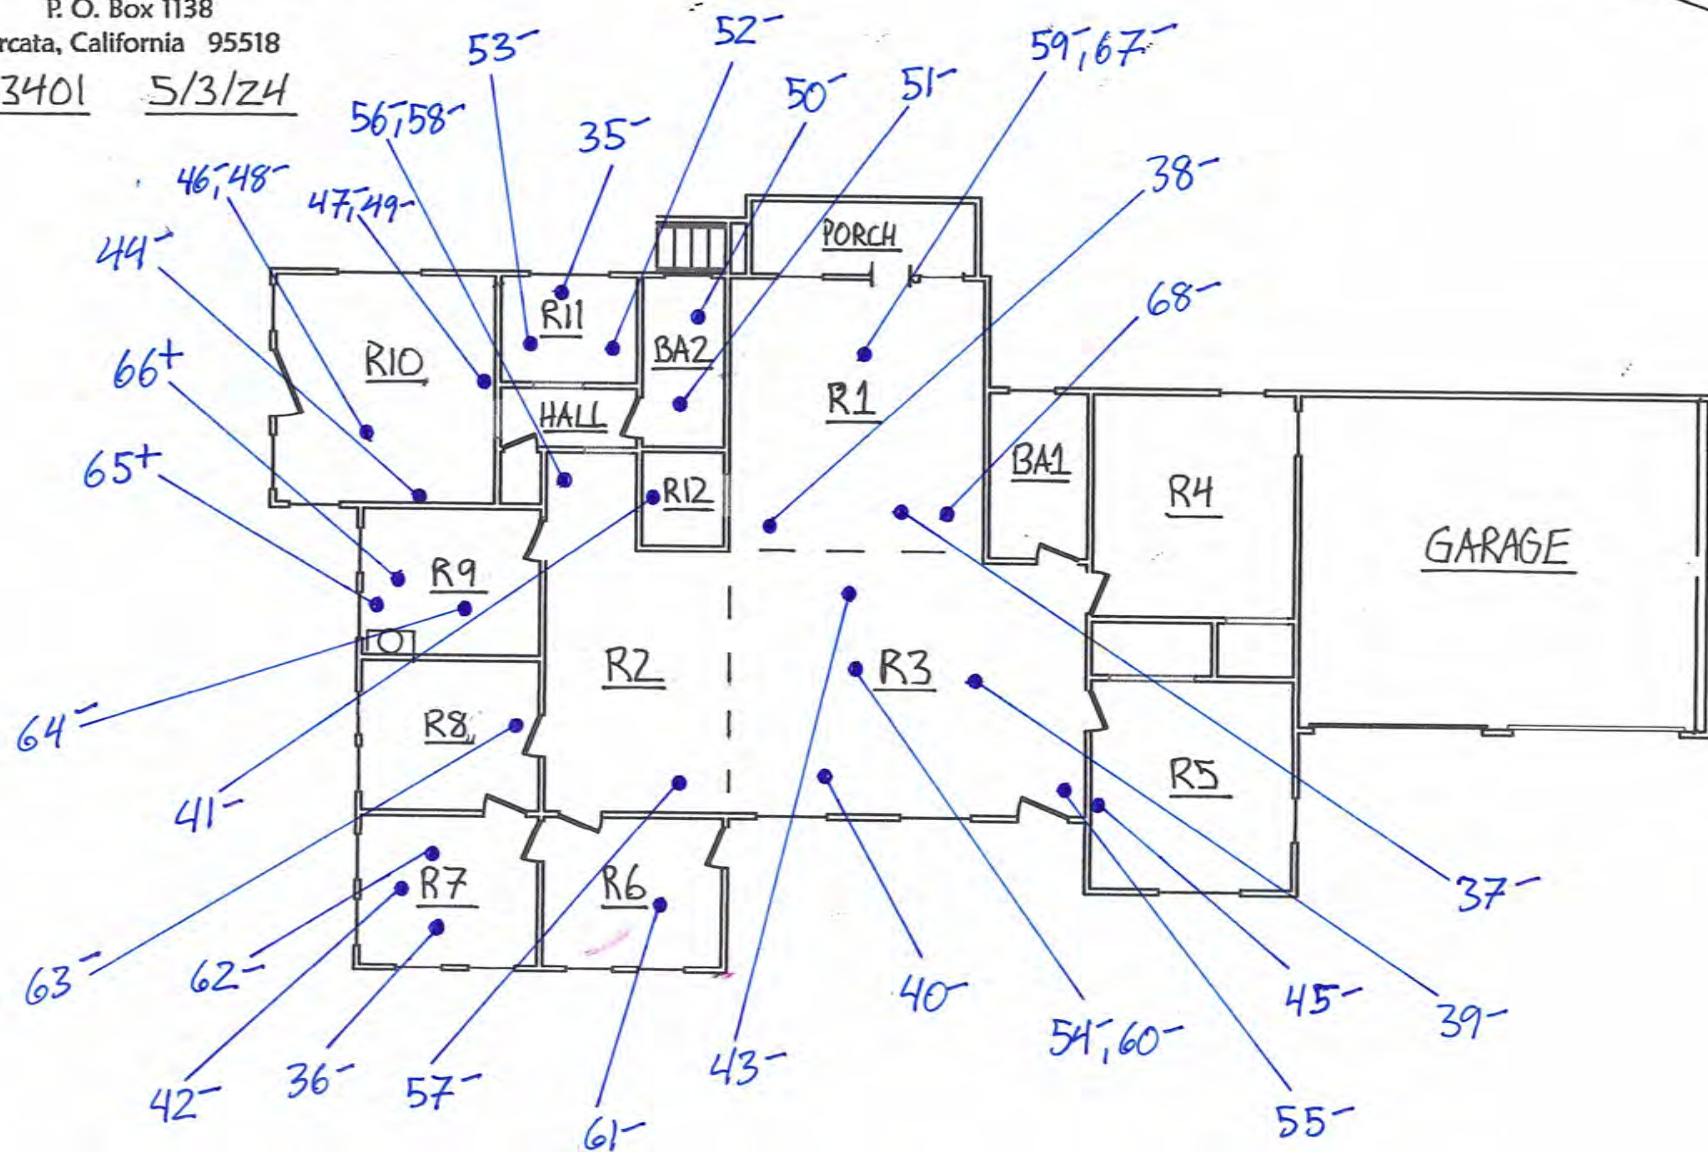
FIG. 2

### ASBESTOS SAMPLE LOCATIONS

(Asbestos Samples: 35-68)

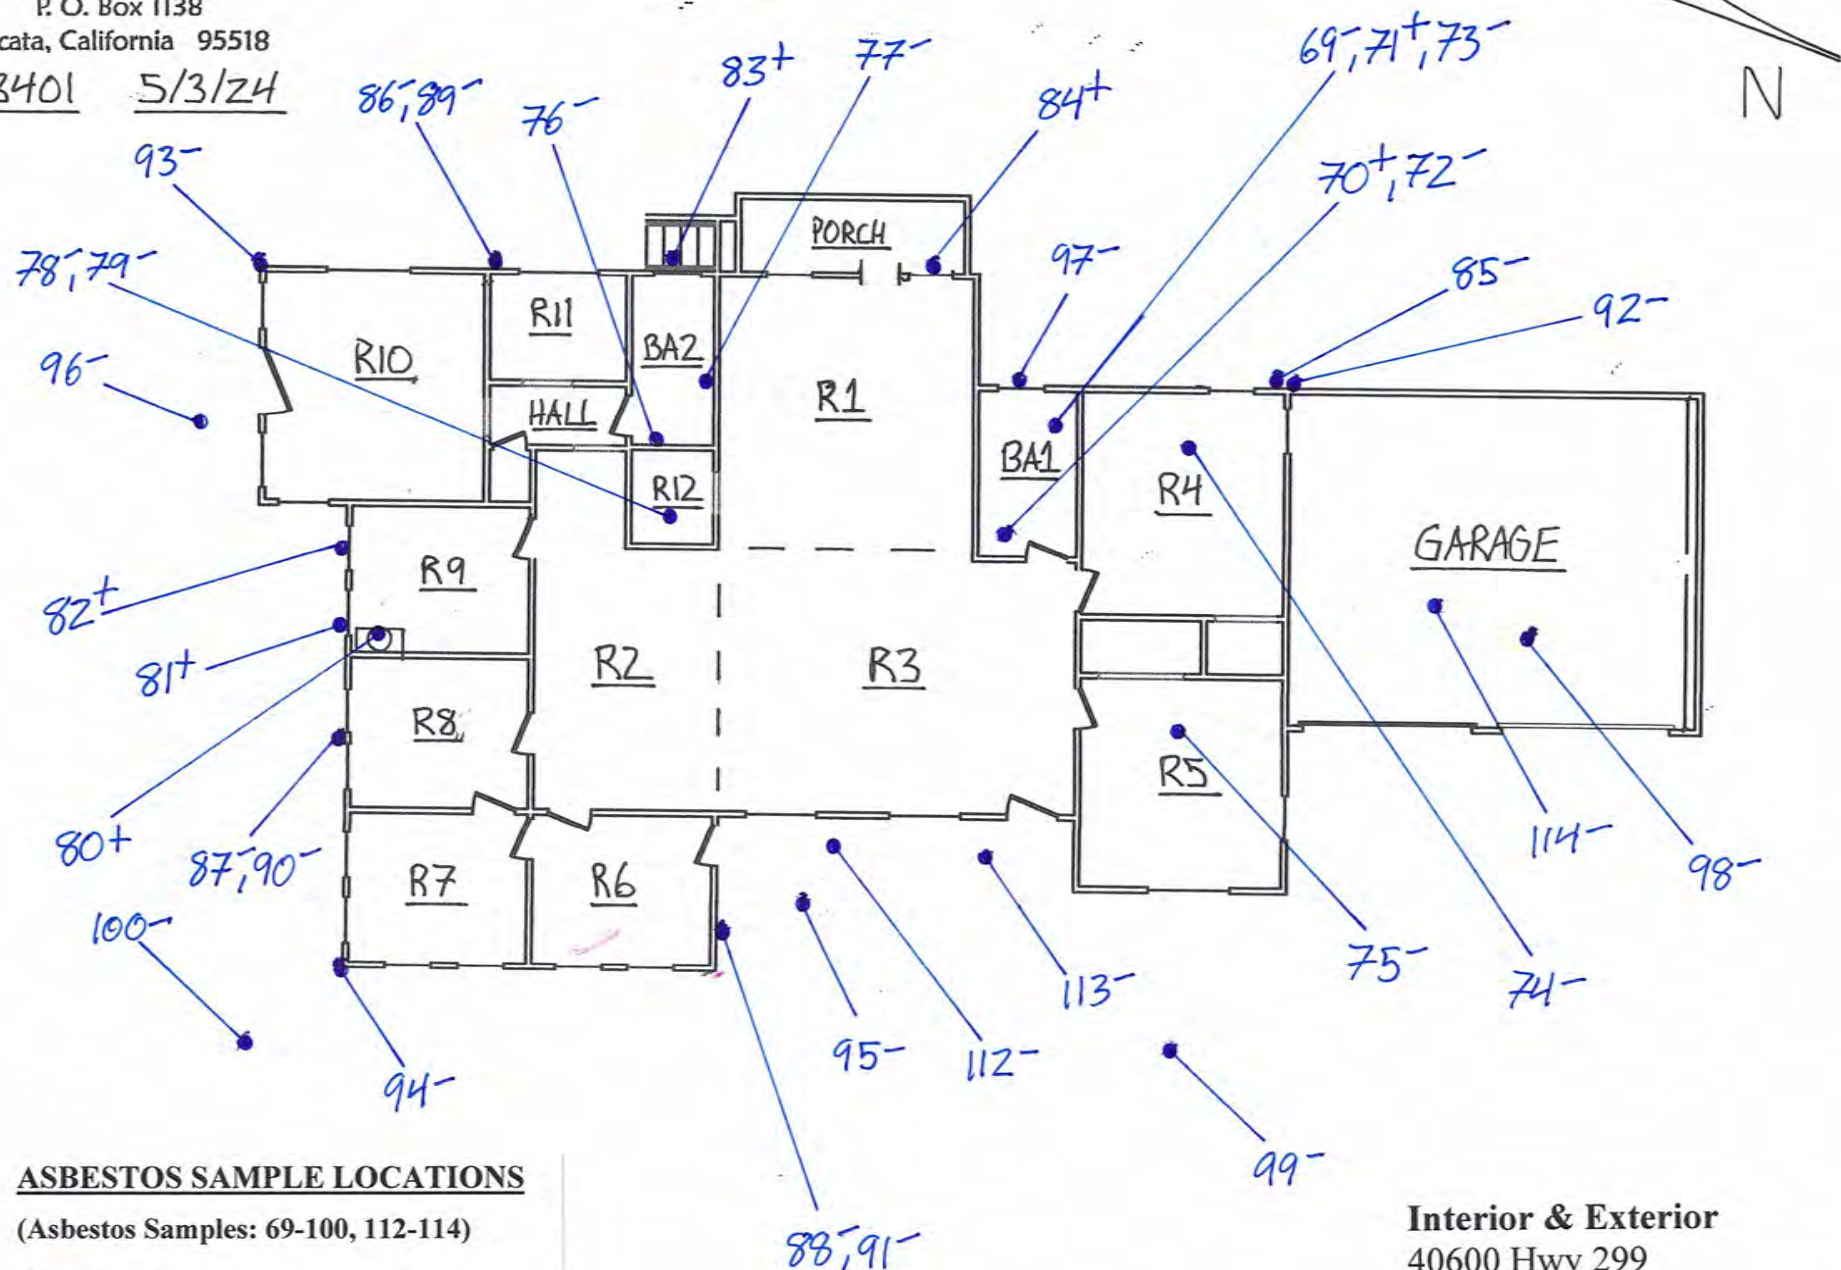
FIG. 3

# ASBESTOS SAMPLE LOCATIONS

(Asbestos Samples: 69-100, 112-114)

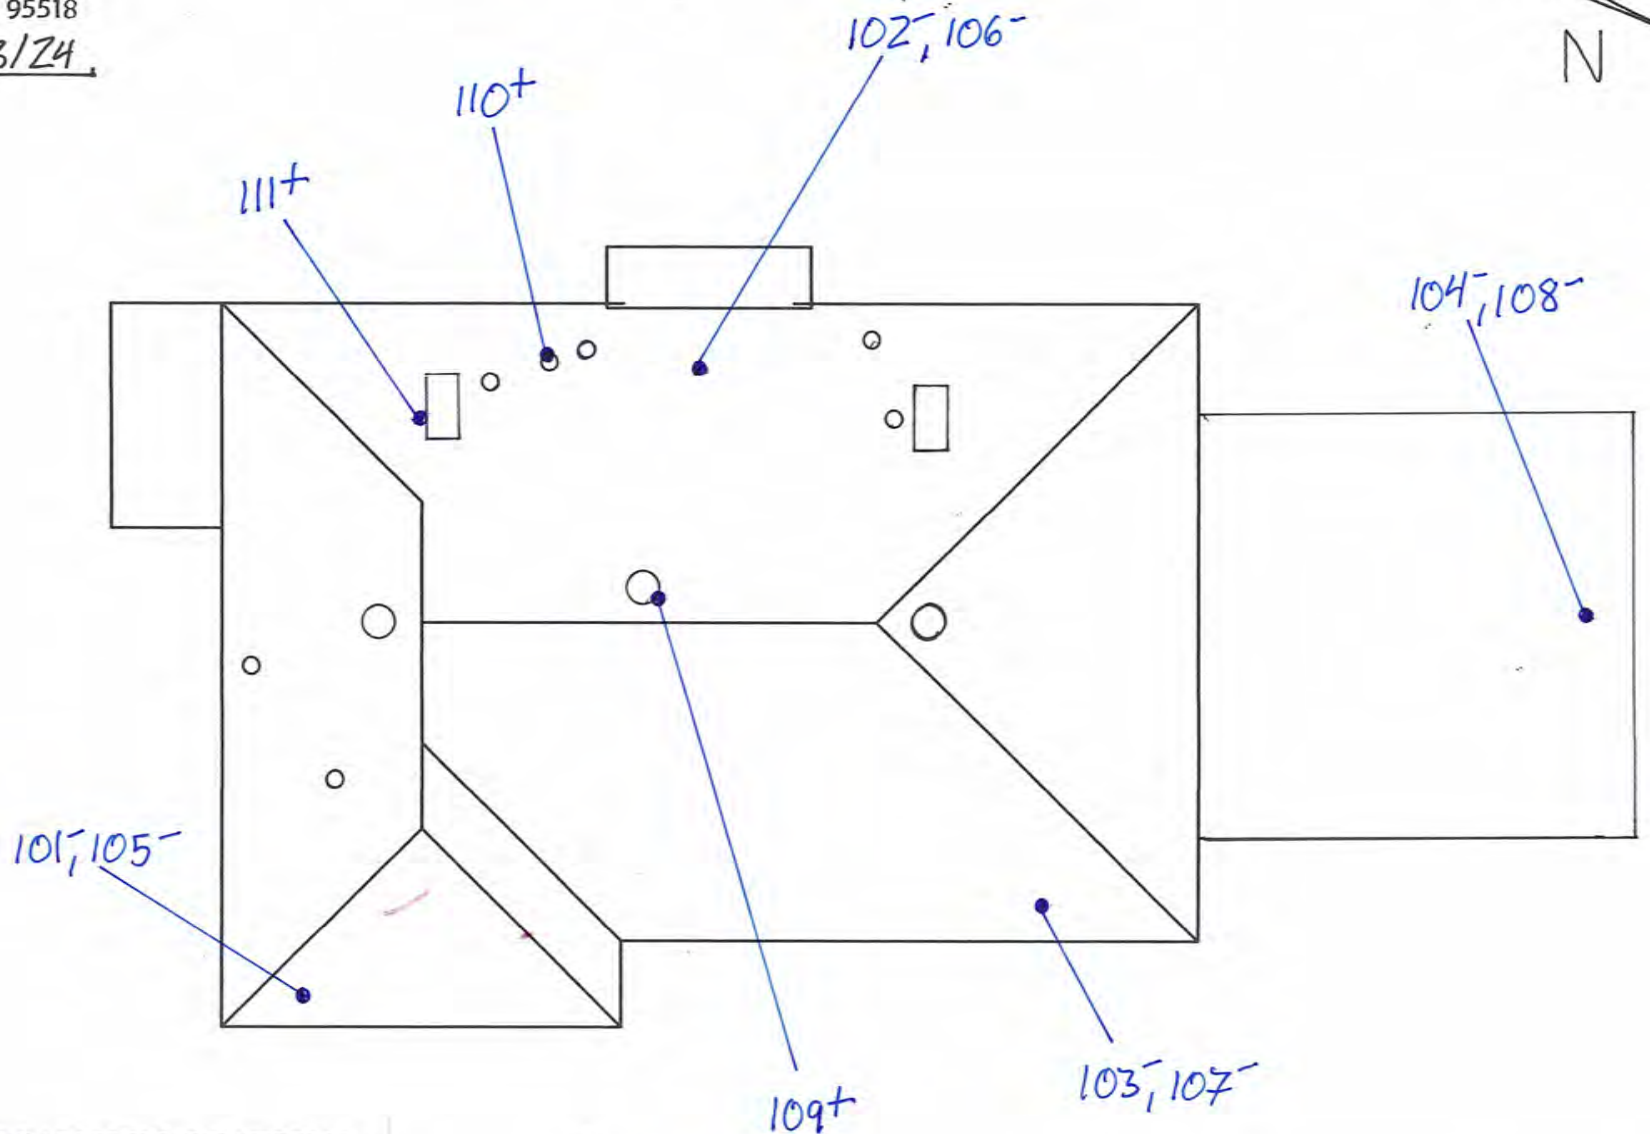
FIG. 4

**ASBESTOS SAMPLE LOCATIONS**

(Asbestos Samples: 101-111)

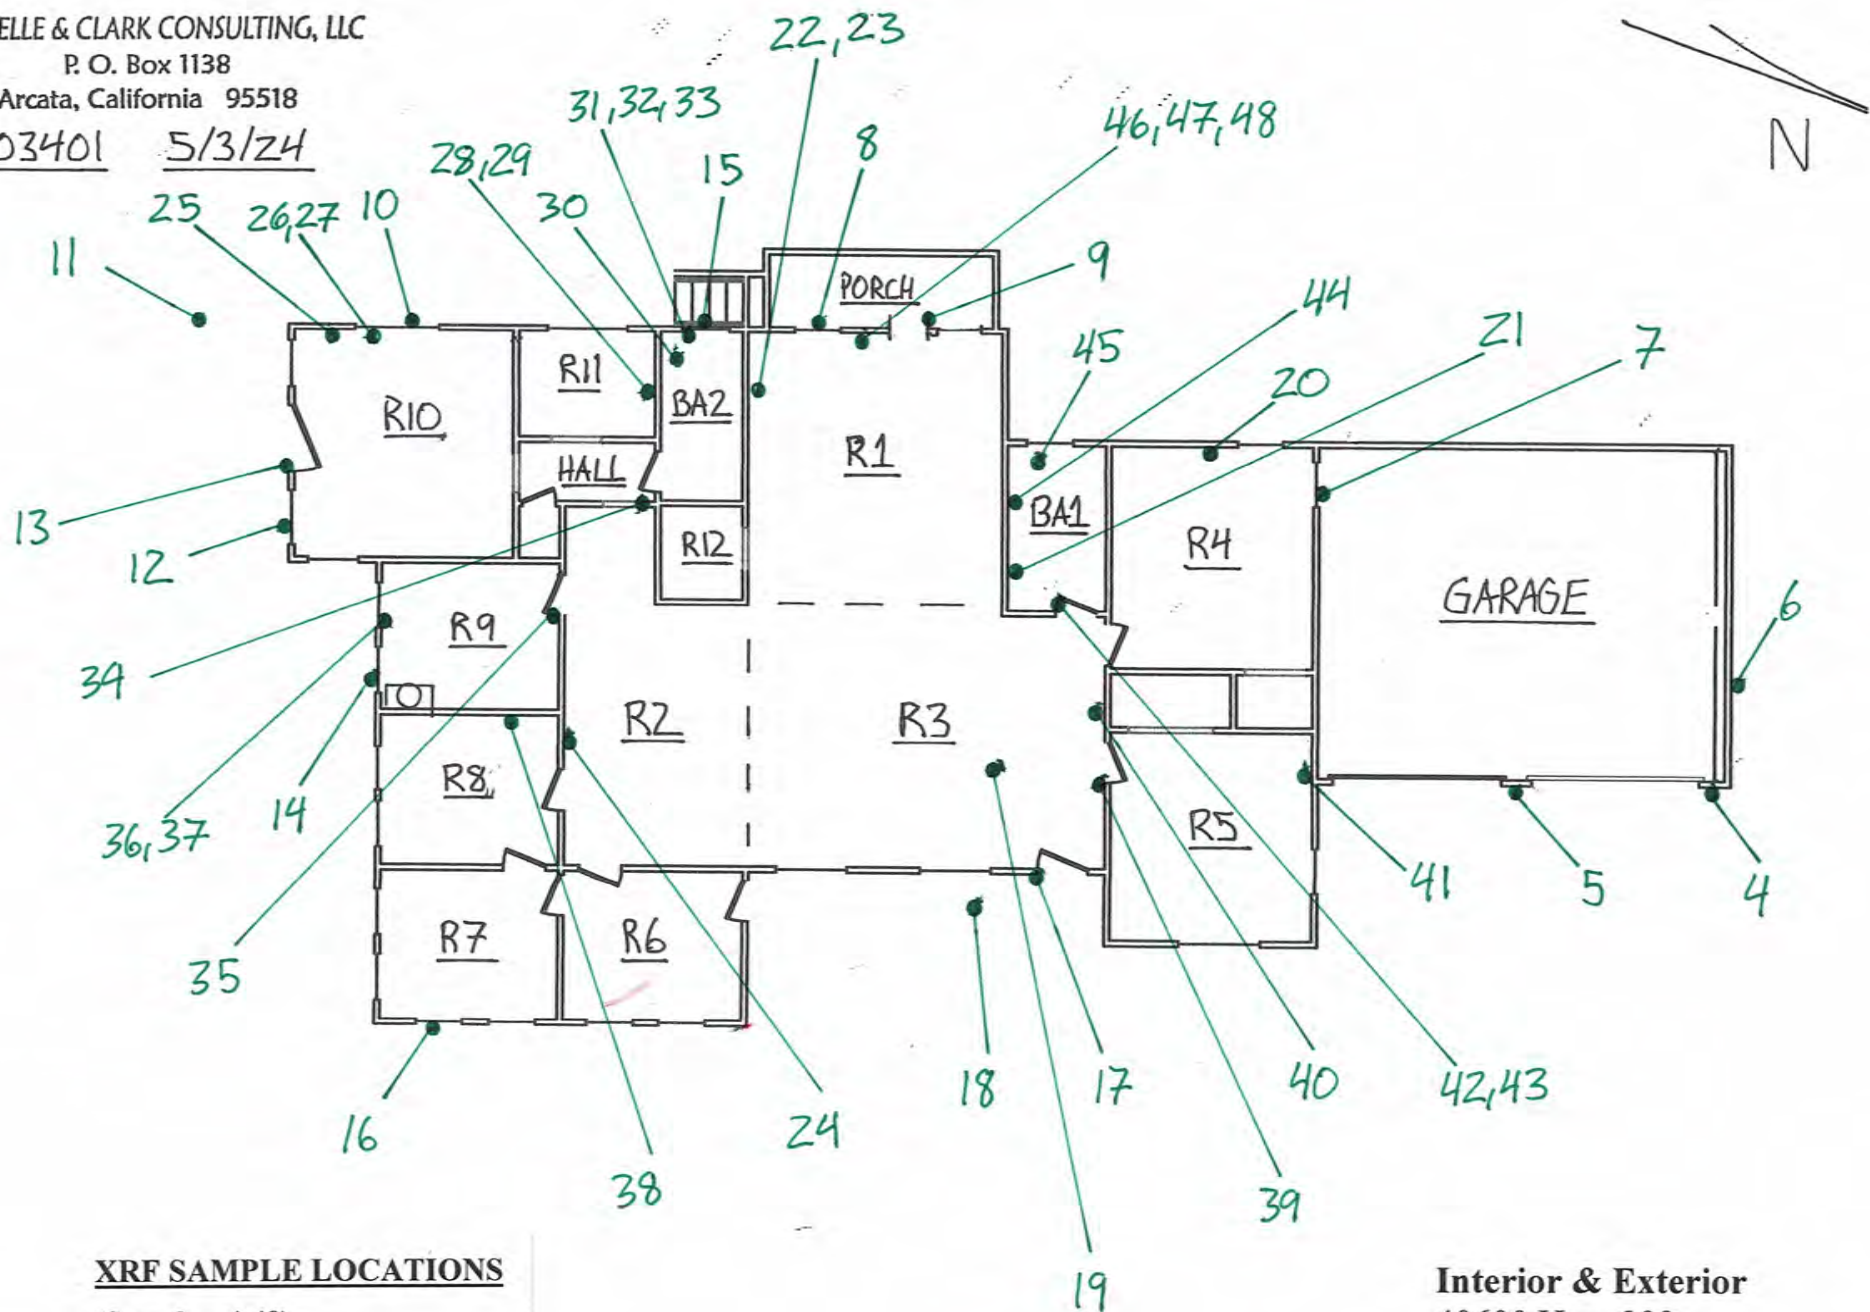
FIG. 5

All sampled components were found to be lead free, or to have trace unquantifiable lead content. See Table 3, Appendix B for all sampling data.

# XRF SAMPLE LOCATIONS

(Samples: 4-48)

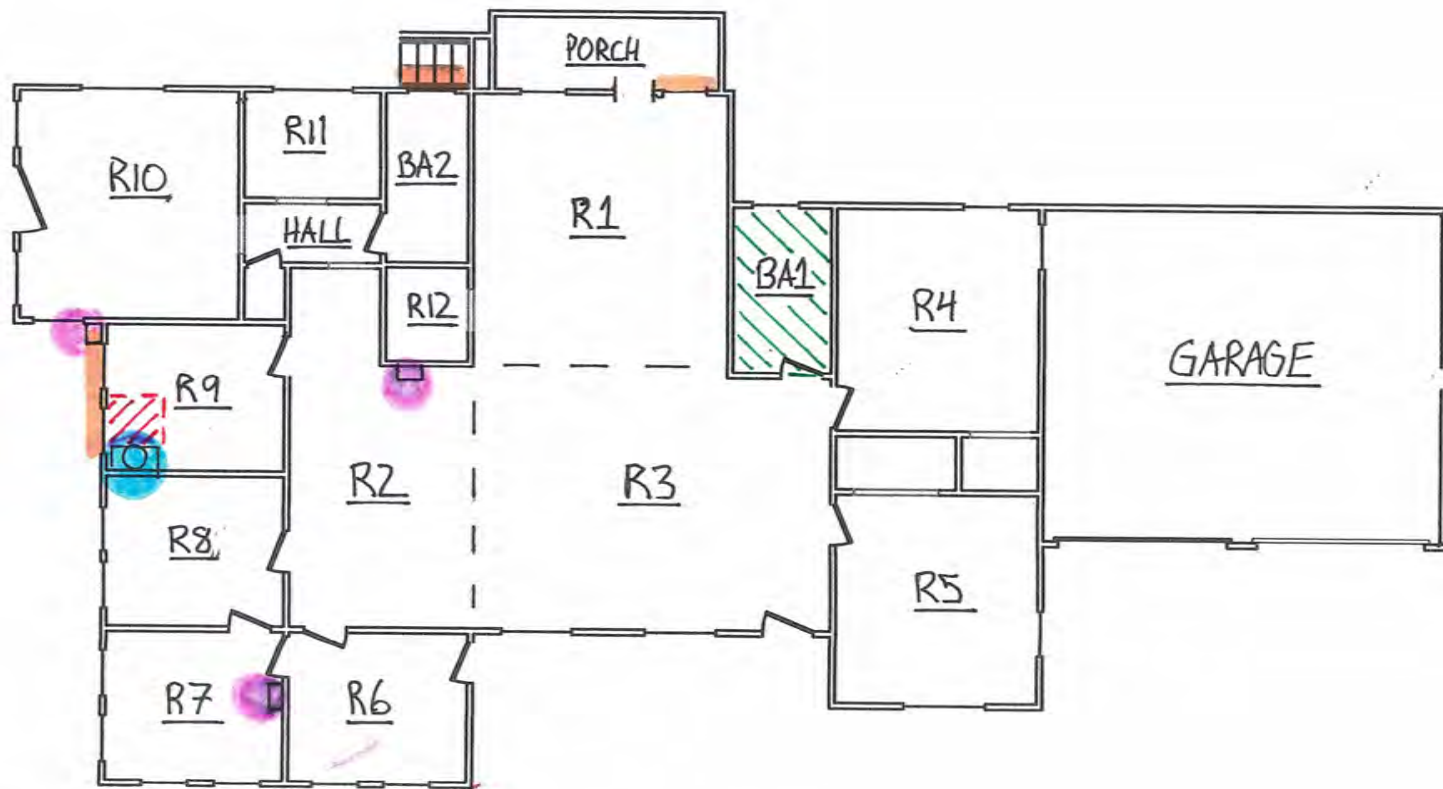
FIG. 6

<b>Window putty, red, gray &amp; white</b> (all window putty is ACM)	<b>Exterior,</b> on 2 windows on the west side, and 2 windows on the south side (See Fig. 6)	Approx. 40 SF (4 windows)	<1-2% CH by initial PLM  0.5-1.9% by 400 Point Count	ACM, Class II abatement required where disturbed	Category I Non-Friable ACM  Not RACM*	Non-friable asbestos waste
<b>Tar roof patch, gray</b> (all roof patch is ACM)	<b>Roof,</b> on and around septic vents, exhaust vents & HVAC unit curbs (See Fig. 7)	Approx. 35 SF	5% CH	ACM, Class II abatement required where disturbed	Category I Non-Friable ACM  Not RACM*	Non-friable asbestos waste

### ASBESTOS LOCATIONS

**RACM Sheet Flooring:** Any abatement or disturbance of the asbestos containing sheet flooring identified in this report must be done by a licensed asbestos abatement contractor using Class II asbestos abatement methods at a minimum. It is recommended herein to augment the standard Class II abatement with negative air containment of the abatement area. The abated material must be disposed of as “friable” asbestos waste. This will require the use of a licensed “hazardous” waste hauler.

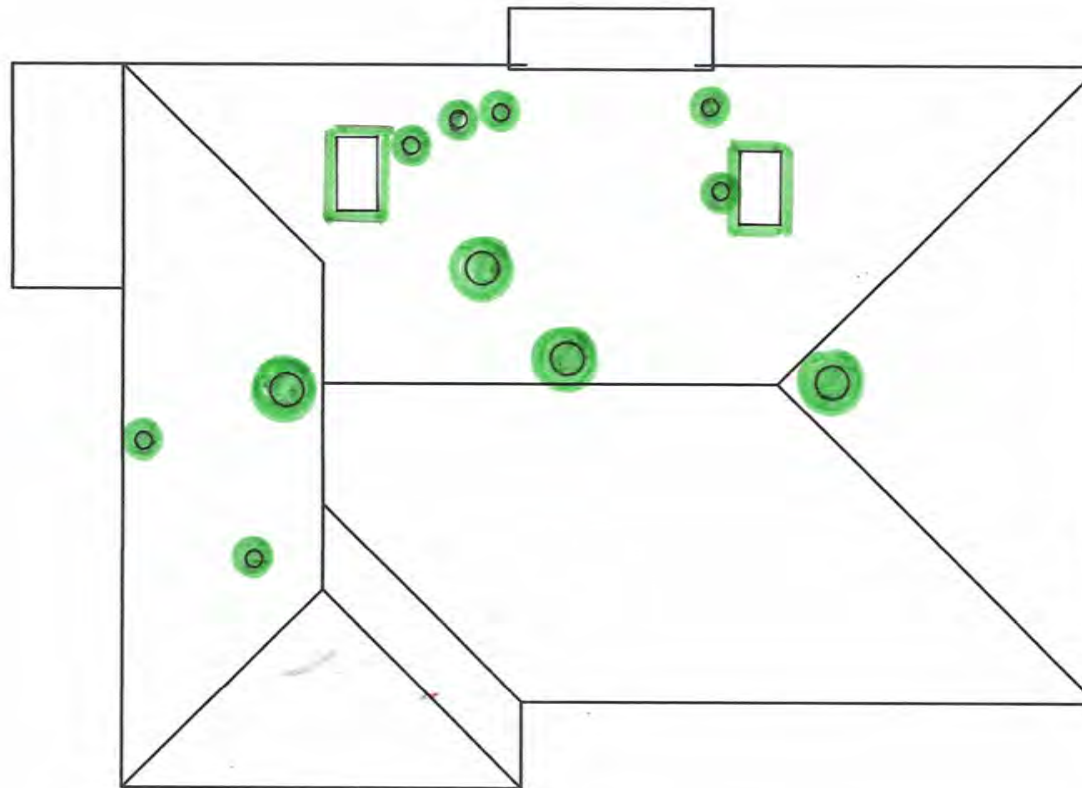
**ASBESTOS LOCATIONS**
