# GEOTECHNICAL INVESTIGATION

## Willow Creek Community Services District Water Tank Brannan Mountain Road Willow Creek, California

Project No. S2904-05-01  
May 15, 2025

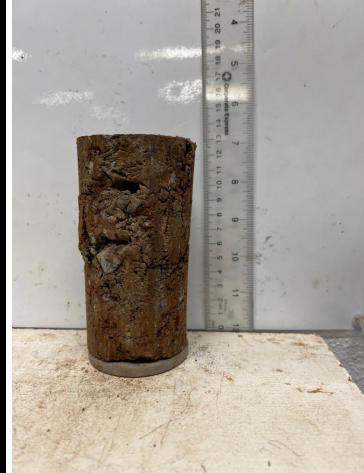
**Figure:** B5

## STRESS-STRAIN

Sample ID	B3-11
Sample Depth (feet)	11.00
Material Description	Strong Brown and Gray Lean CLAY with Gravel
